DEPARTMENT OF TRANSPORTATION

Contract #: 04-0120F4Cty: SF/ALA Rte: 80 PM: 13.2/13.9File #: 1.28**WELDING INSPECTION REPORT****Resident Engineer:** Casey, William**Address:** 333 Burma Road**City:** Oakland, CA 94607**Report No:** WIR-028096**Date Inspected:** 02-Aug-2012**Project Name:** SAS Superstructure**OSM Arrival Time:** 700**Prime Contractor:** American Bridge/Fluor Enterprises, a JV**OSM Departure Time:** 1930**Contractor:** American Bridge/Fluor Enterprises, a JV**Location:** Job Site**CWI Name:** As noted below.**CWI Present:** Yes No**Inspected CWI report:** Yes No N/A**Rod Oven in Use:** Yes No N/A**Electrode to specification:** Yes No N/A**Weld Procedures Followed:** Yes No N/A**Qualified Welders:** Yes No N/A**Verified Joint Fit-up:** Yes No N/A**Approved Drawings:** Yes No N/A**Approved WPS:** Yes No N/A**Delayed / Cancelled:** Yes No N/A**Bridge No:** 34-0006**Component:** Tower**Summary of Items Observed:**

Electroslag Weld Excavation / Repair

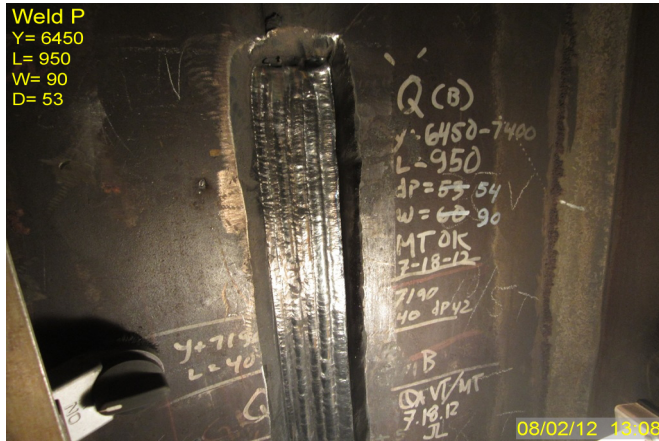
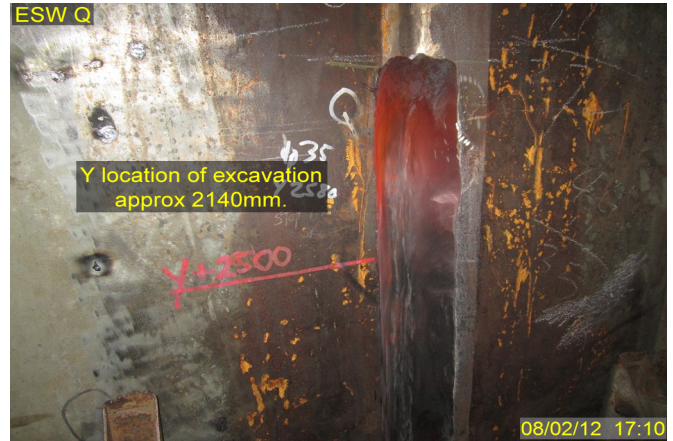
The UT discovered indication was found to be oriented in the longitudinal position. The indication was found to be rejectable per AWS D1.5 Table 6.4).

The weld being excavated is designated as "ESW Q" and was excavated on Face B at location:

Weld "Q" - Excavation is in-process. Final measurements have not been taken.

Please see attached photographs indication discovered during excavation.

Weld "Q" - Y= 6450mm, L= 950mm, W= 90mm, D= 53mm

This QA observed, at random intervals, ABF/JV qualified welder James Zhen #6001 continue performing Flux Core Arc Welding (FCAW) implementing Caltrans approved Welding Procedure Specification (WPS) ABF-WPS-D15-3000-3Repair. The joint being welded was tower shear plate designated as ESW weld, location "Q" from face B.
